新生命教育協會平安福音中學
NLSI PEACE EVANGELICAL SECONDARY
SCHOOL

Roof Heat Rejected Coating – *Test Report*

Location: **Roof of the School**

Aim: **To test the efficiency of the Roof Heat Rejected Coating after applied for 11 months**

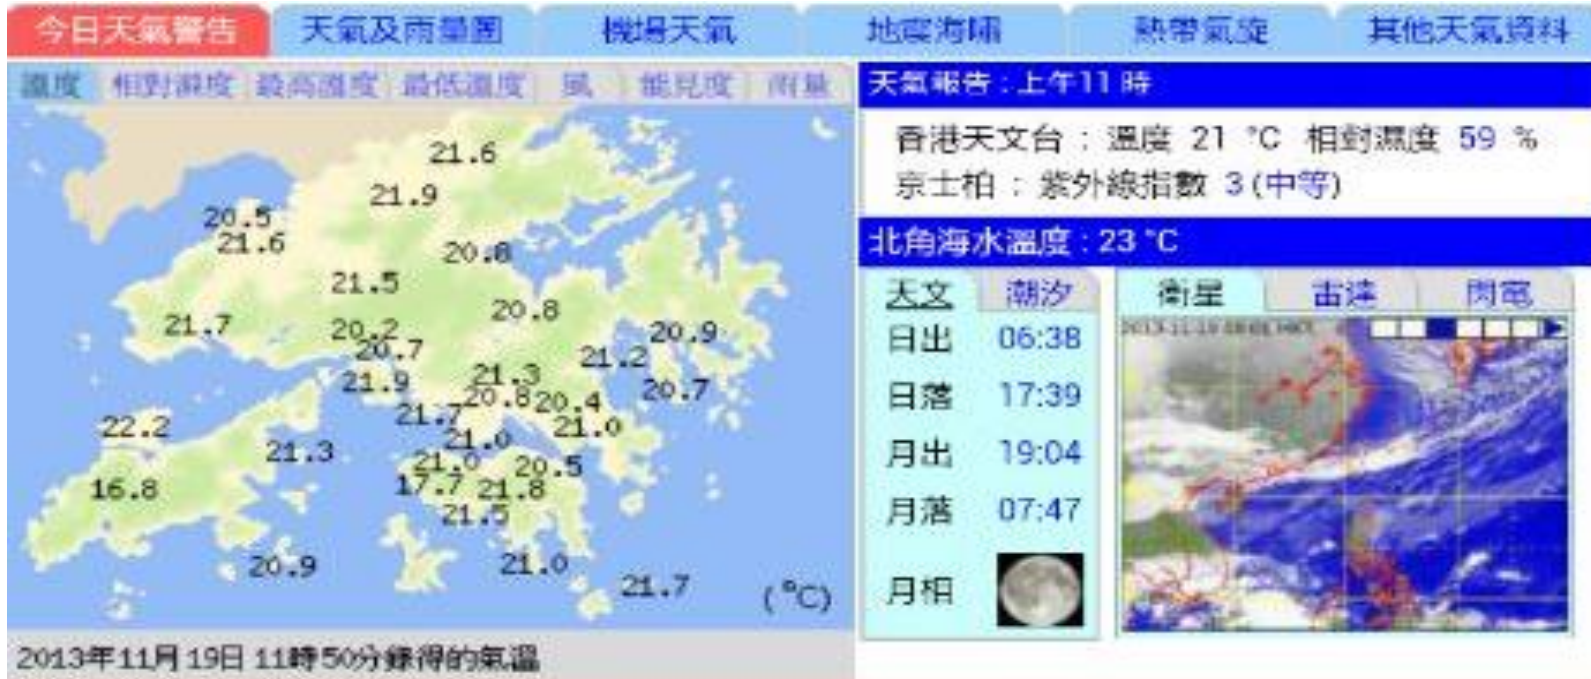
Weather on 19/11/2013

The different between coated and uncoated will not so big Due to the external factor (weather) affects

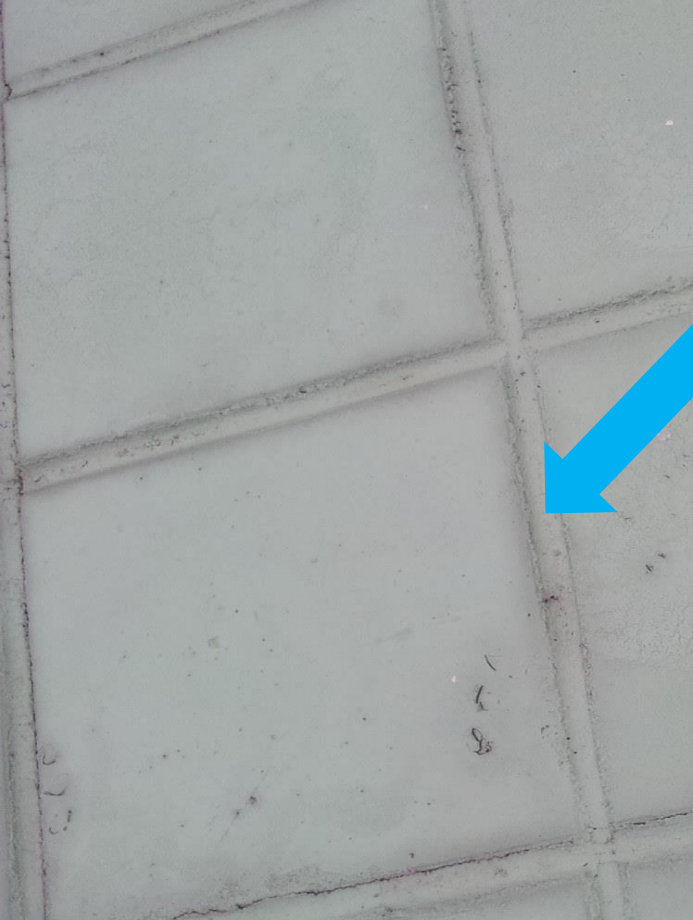
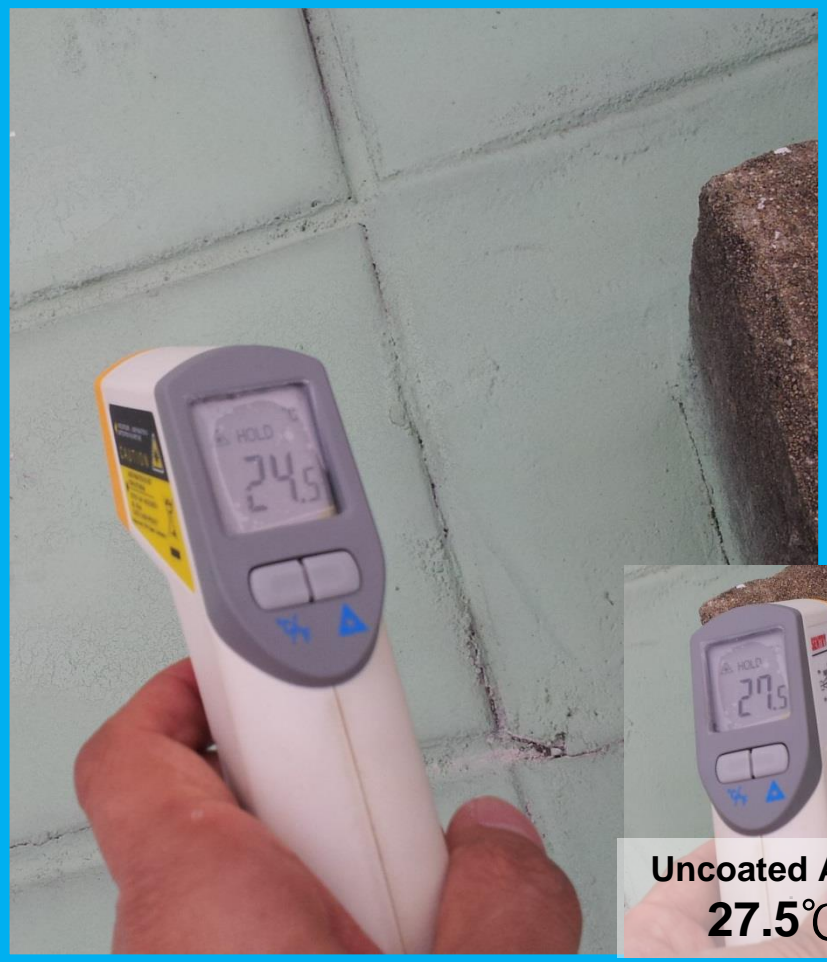
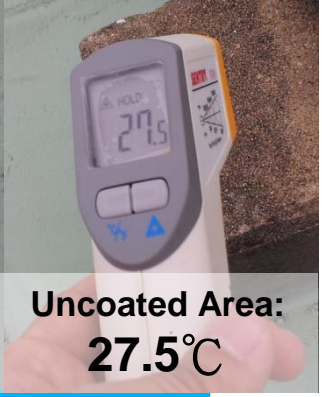
Temperature Recorded: 24.5°C (coated) , 27.5 °C (uncoated)

Uncoated Area:
27.5°C

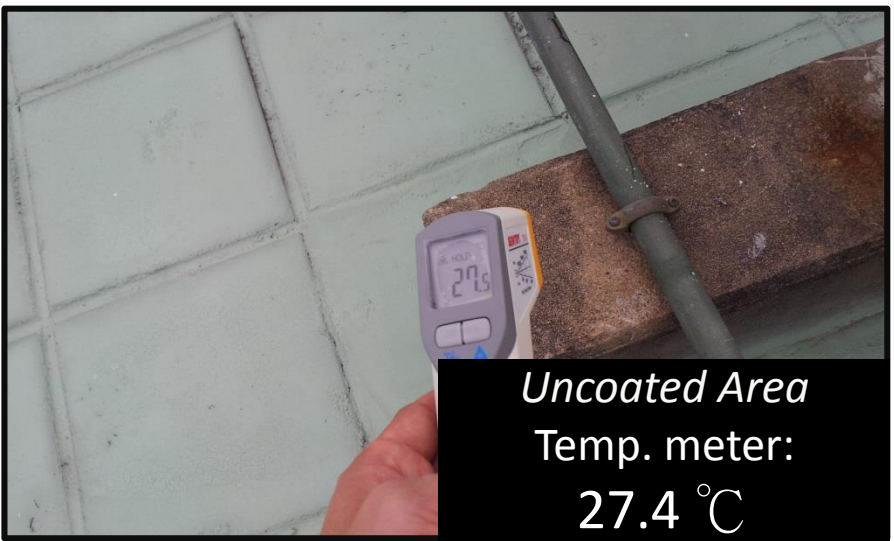
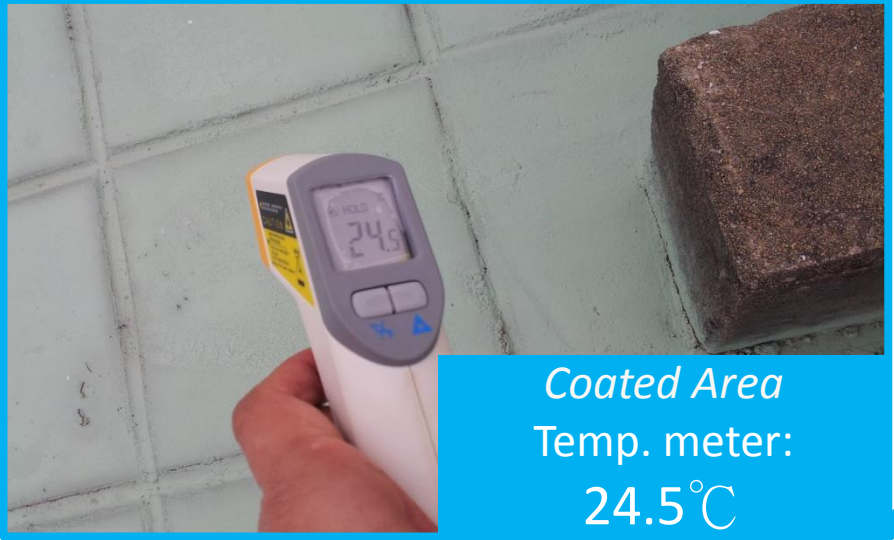
Temperature Test: *Uncoated VS Coated* roof area

Temperature Reduced:
2.9 °C

***The different between coated and uncoated will not so big Due to the external factor

(weather) affects
